**Flood Control Project Maintenance
Levee Inspections**

Fall 2012 Levee Maintenance Deficiency Summary Report

San Joaquin River Basin

Reclamation District No. 2062 Stewart

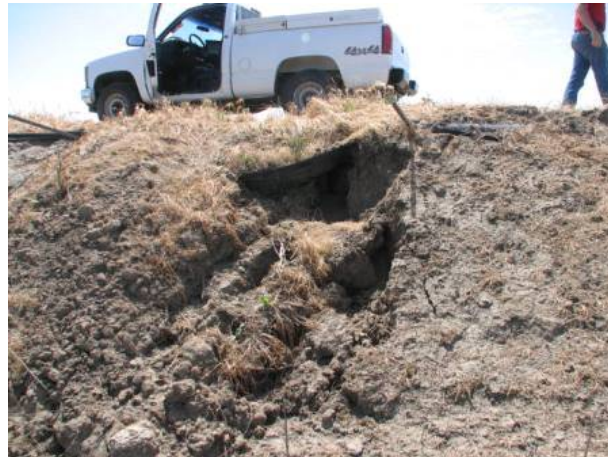
Levee Mile Report Line	5
Start Levee Mile	0.50
End Levee Mile	0.50
Location	Water Side
Category	Earthen Levee
Item	Erosion / Bank Caving

05/11/2011 Erosion at crown, vegetation shown at top of erosion is being supported by silt fence.

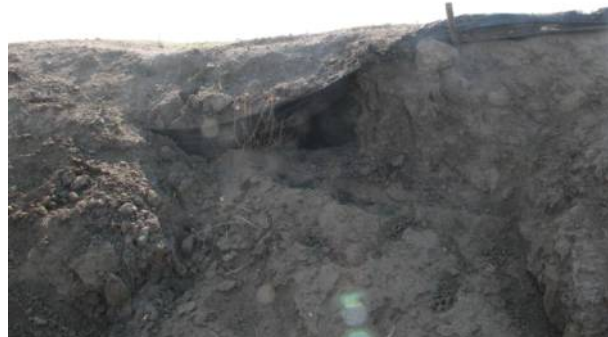
Levee Mile Report Line	5
Start Levee Mile	0.50
End Levee Mile	0.50
Location	Water Side
Category	Earthen Levee
Item	Erosion / Bank Caving

10/21/2011 Erosion at crown, issue first noted in Spring 2011 inspection.

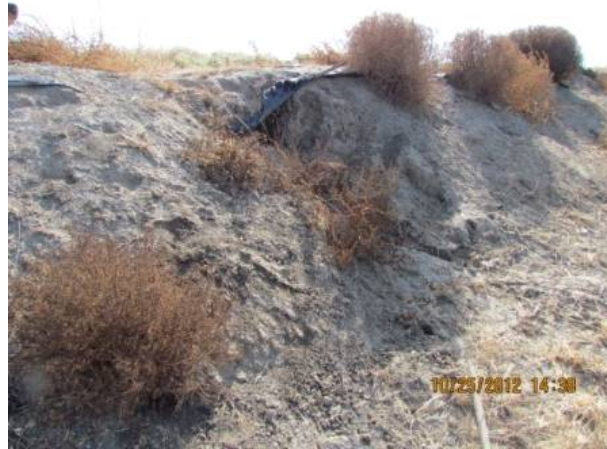
View of erosion at crown on waterside slope.

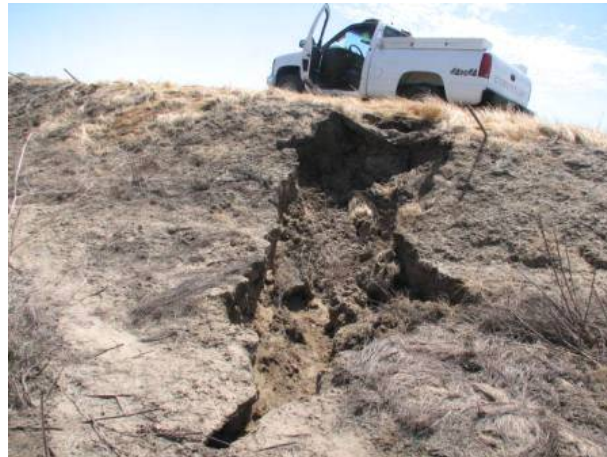
Levee Mile Report Line	6
Start Levee Mile	0.57
End Levee Mile	0.57
Location	Water Side
Category	Earthen Levee
Item	Erosion / Bank Caving

05/11/2011 Erosion begins at crown, stakes shown in photo are supporting a silt fence. Silt fence is supporting soil and vegetation at crown.

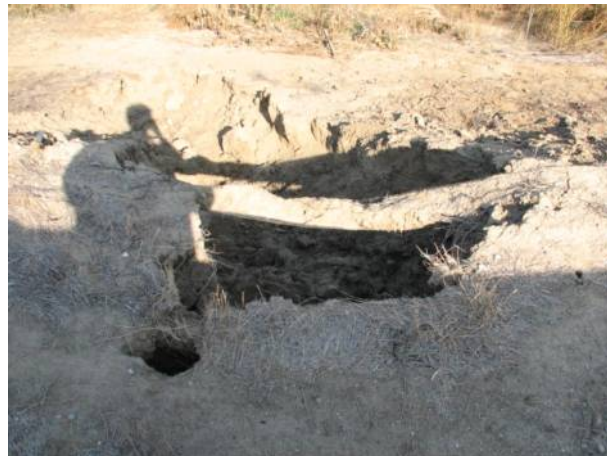
Levee Mile Report Line	6
Start Levee Mile	0.57
End Levee Mile	0.57
Location	Water Side
Category	Earthen Levee
Item	Erosion / Bank Caving

10/21/2011 Photo is taken from levee crown, issue has still not been addressed. Issue was noted in the Spring 2011 inspection.

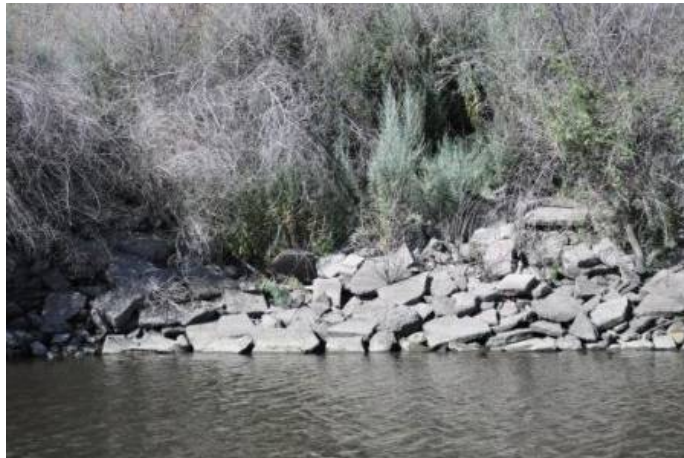
Front view of the erosion site

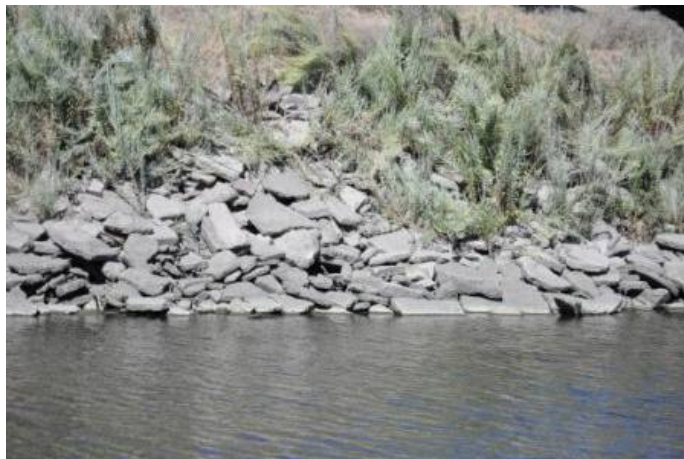
Levee Mile Report Line	8
Start Levee Mile	0.91
End Levee Mile	0.91
Location	Water Side
Category	Supplemental
Item	DWR Erosion Survey

Front view of the rip rap

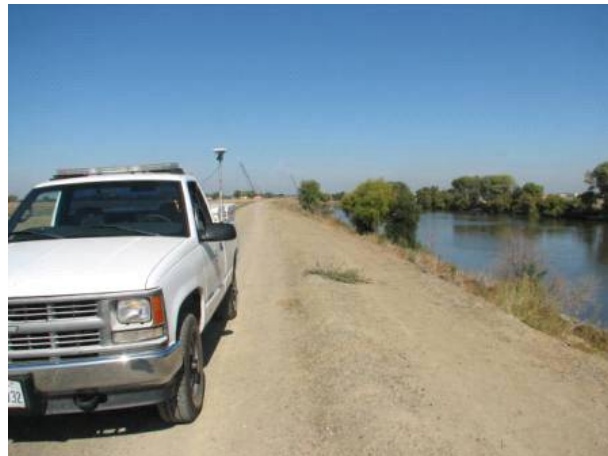
Levee Mile Report Line	9
Start Levee Mile	1.18
End Levee Mile	1.40
Location	Crown
Category	Earthen Levee
Item	Crown Surface / Depressions / Rutting

10/20/2011 Berm is forming on the waterside edge of the crown. Berm is approximately 1' high in places.

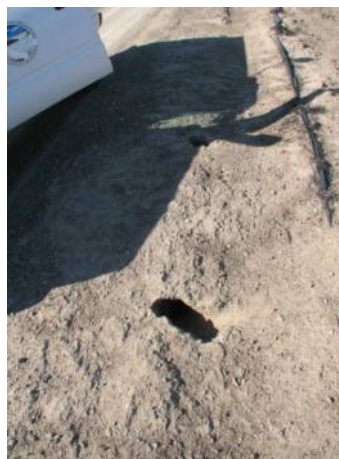
Levee Mile Report Line	11
Start Levee Mile	1.83
End Levee Mile	1.83
Location	Water Side
Category	Earthen Levee
Item	Animal Control

10/20/2011 Large burrow located near crown on waterside slope of levee.

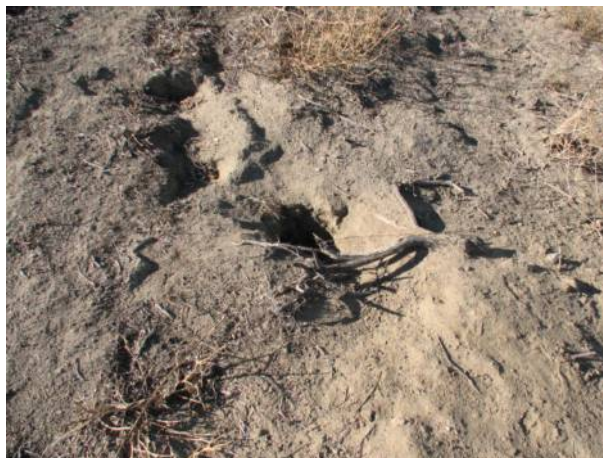
Levee Mile Report Line	11
Start Levee Mile	1.83
End Levee Mile	1.83
Location	Water Side
Category	Earthen Levee
Item	Animal Control

10/20/2011 Large burrow located on waterside slope of levee.

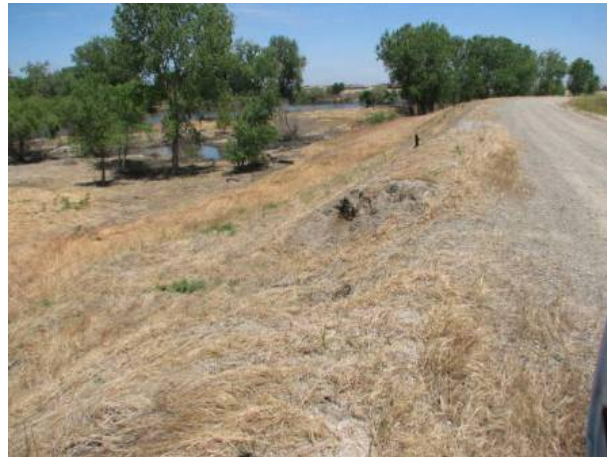
Levee Mile Report Line	15
Start Levee Mile	2.10
End Levee Mile	2.10
Location	Water Side
Category	Earthen Levee
Item	Slope Stability

05/11/2011 Damage seen in photo continues down the slope as if area was being used by equipment to access the bank.

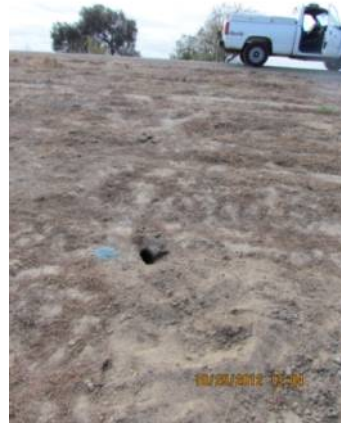
Levee Mile Report Line	6
Start Levee Mile	2.04
End Levee Mile	2.04
Location	Land Side
Category	Earthen Levee
Item	Animal Control

View of bait next to active burrow on landside slope.

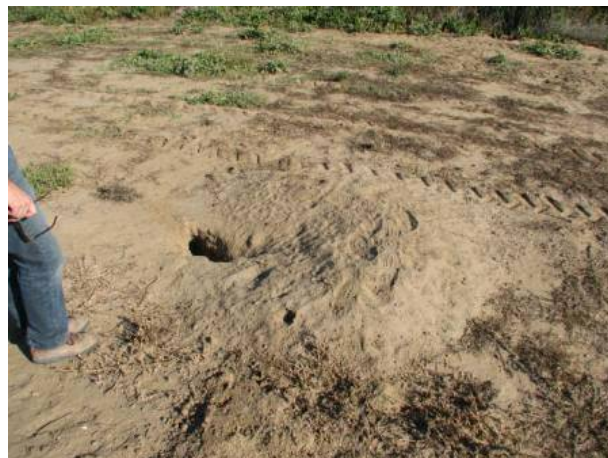
Levee Mile Report Line	7
Start Levee Mile	2.10
End Levee Mile	2.10
Location	Land Side
Category	Earthen Levee
Item	Animal Control

10/20/2011 Photo shows single large burrow, which appears to be active.

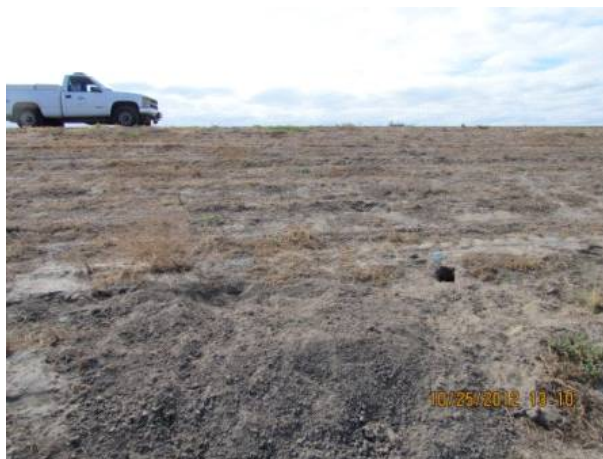
Levee Mile Report Line	7
Start Levee Mile	2.10
End Levee Mile	2.10
Location	Land Side
Category	Earthen Levee
Item	Animal Control

View of active burrows on landside slope.

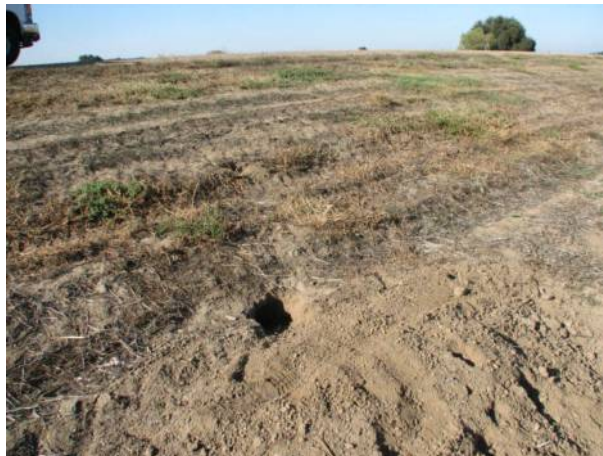
Levee Mile Report Line	8
Start Levee Mile	2.19
End Levee Mile	2.19
Location	Land Side
Category	Earthen Levee
Item	Animal Control

10/20/211 Single large burrow on landside, appears to be active.

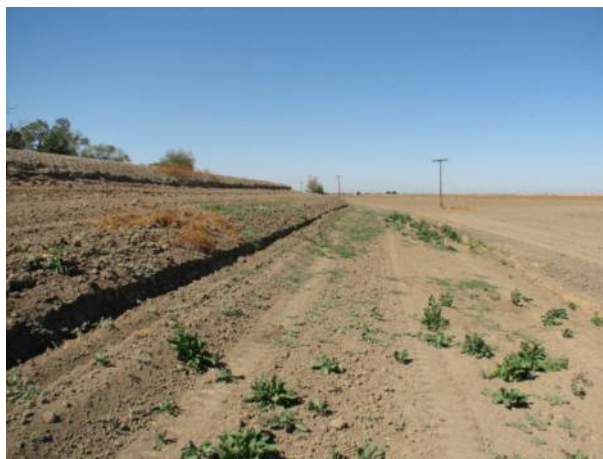
Levee Mile Report Line	10
Start Levee Mile	2.54
End Levee Mile	3.94
Location	Land Side
Category	Earthen Levee
Item	Encroachments

Discing on levee slopes has created two substantial vertical scarps.

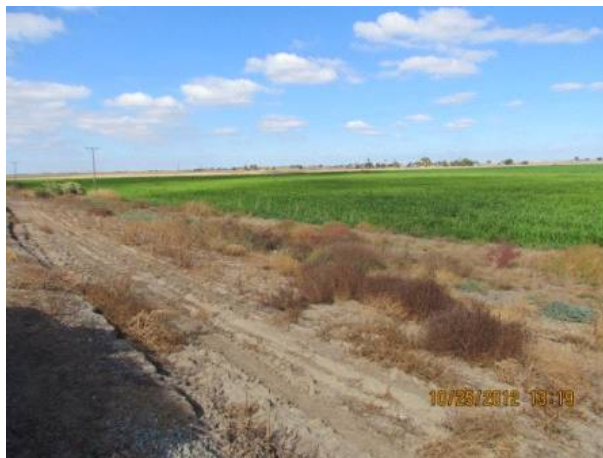
Levee Mile Report Line	11
Start Levee Mile	2.61
End Levee Mile	3.87
Location	Land Side
Category	Earthen Levee
Item	Vegetation

View of tall vegetation at landside toe.

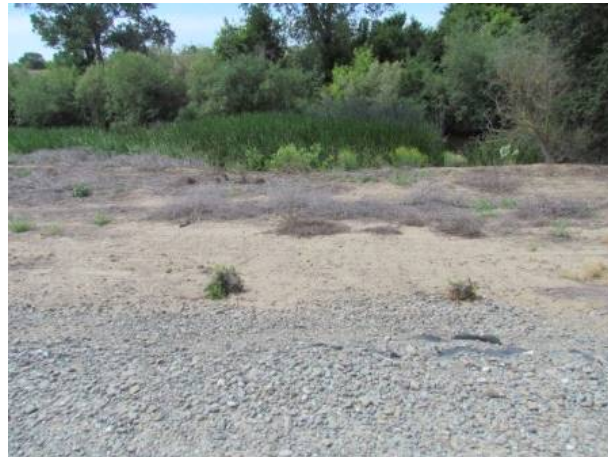
Levee Mile Report Line	14
Start Levee Mile	2.94
End Levee Mile	2.94
Location	Water Side
Category	Earthen Levee
Item	Trim / Thin Trees

View of tree stumps on waterside slope.
05/17/2012

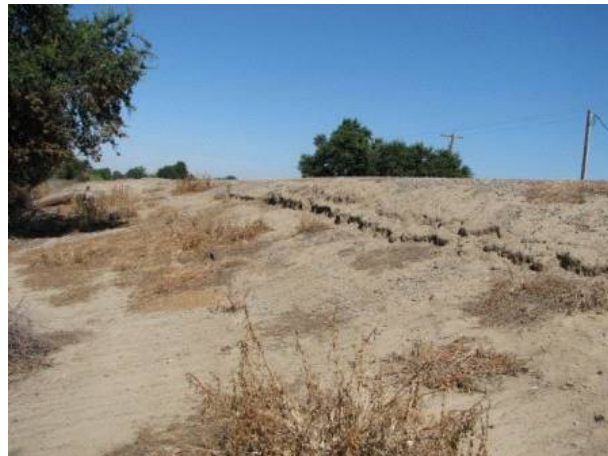
Levee Mile Report Line	18
Start Levee Mile	3.27
End Levee Mile	3.28
Location	Water Side
Category	Supplemental
Item	DWR Erosion Survey

Downstream view of scarp caused by a maintenance equipment.

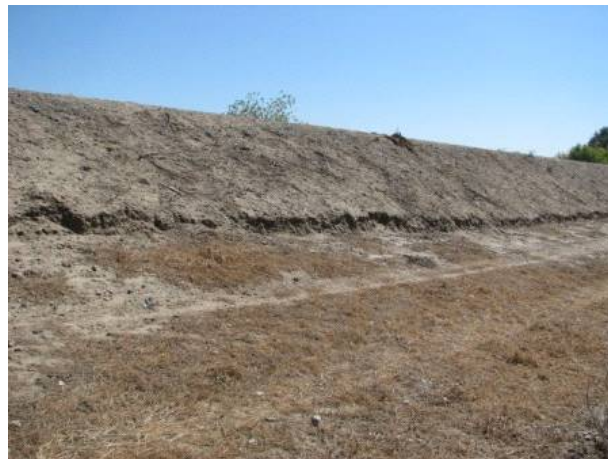
Levee Mile Report Line	20
Start Levee Mile	3.44
End Levee Mile	3.53
Location	Water Side
Category	Supplemental
Item	DWR Erosion Survey

Upstream view of site. Note the vertical scarp at the toe.

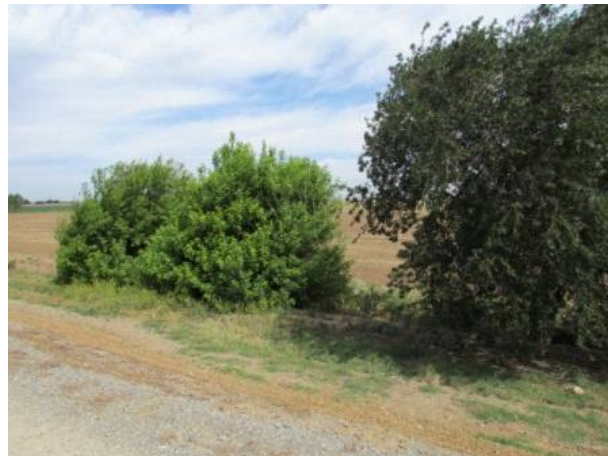
Levee Mile Report Line	21
Start Levee Mile	3.45
End Levee Mile	3.45
Location	Land Side
Category	Earthen Levee
Item	Trim / Thin Trees

View of bushy trees at levee toe obstructing visibility. 05/17/2012

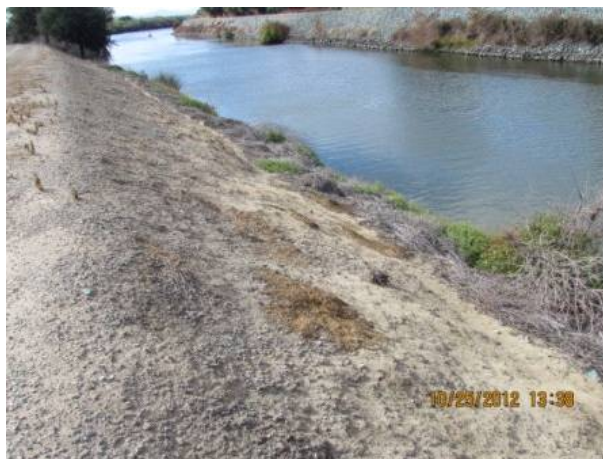
Levee Mile Report Line	2
Start Levee Mile	0.08
End Levee Mile	0.08
Location	Water Side
Category	Earthen Levee
Item	Trim / Thin Trees

View of tree stumps on waterside slope.

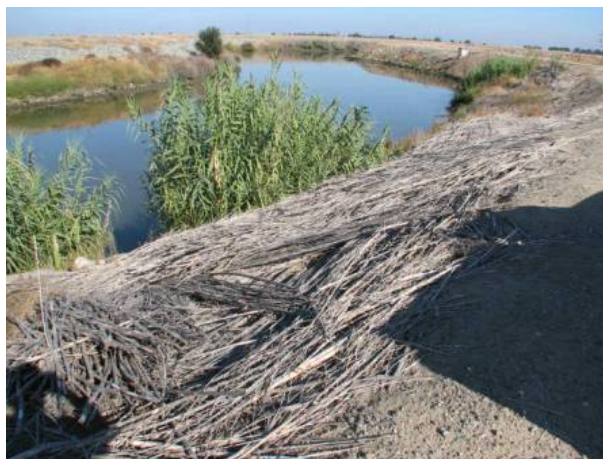
Levee Mile Report Line	9
Start Levee Mile	0.46
End Levee Mile	0.46
Location	Water Side
Category	Earthen Levee
Item	Encroachments

10/20/2011 Bamboo (Arundo) cuttings still present issue is not being addressed.

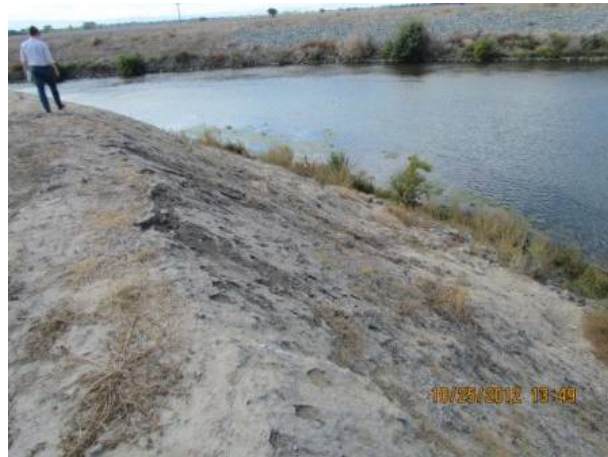
Levee Mile Report Line	15
Start Levee Mile	0.82
End Levee Mile	0.82
Location	Water Side
Category	Earthen Levee
Item	Erosion / Bank Caving

15	0.82	0.82	Earthen Levee	Erosion / Bank Caving	WS	M Ma	E2 : Schedule repair of erosion site prior to the next inspection.	37.816315 ° -121.381587 °	37.816315 ° -121.381587 °	11 Y
DWR ID: DWR_RD2062_03_s_2012_11

View of slope erosion from foot traffic.

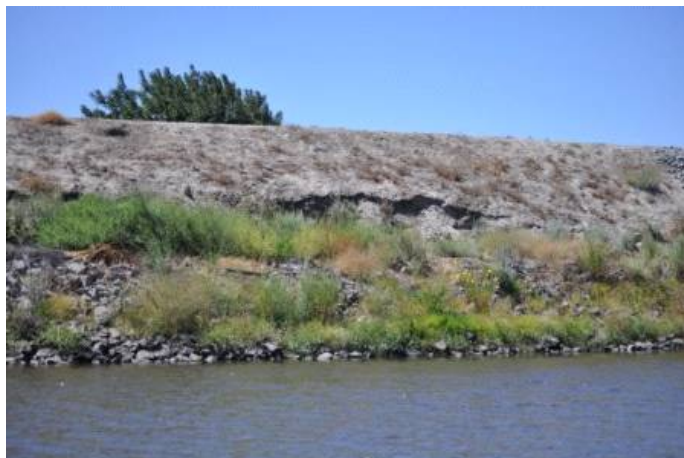
Levee Mile Report Line	16
Start Levee Mile	1.20
End Levee Mile	1.21
Location	Water Side
Category	Supplemental
Item	DWR Erosion Survey

Front view of the site. Existing scalloped erosion is immediately downstream of rip rap section.

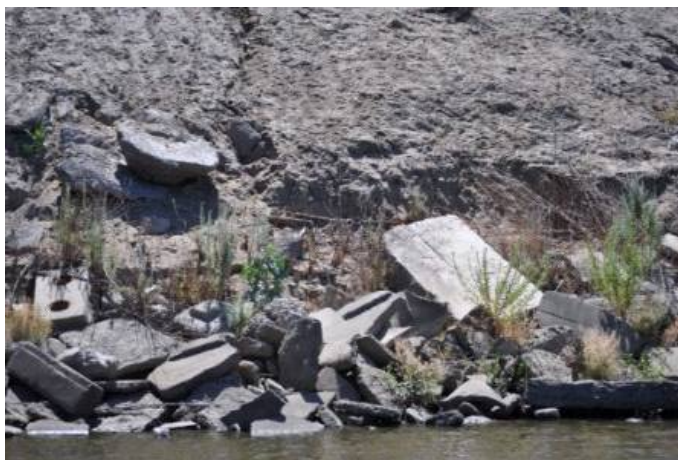
Front view of the site. Note existing broken concrete on the upper slope as well as on the lower slope and at the toe.

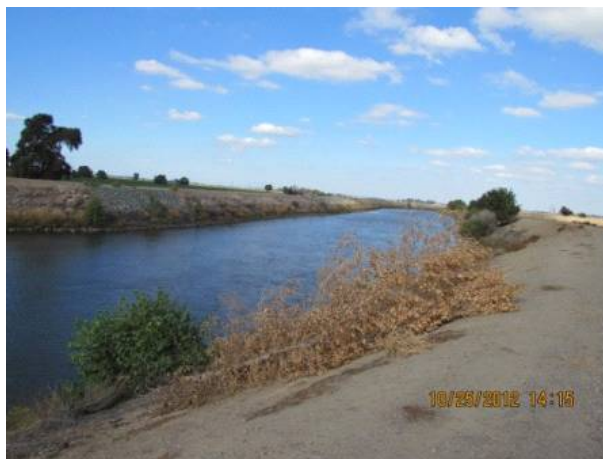
Levee Mile Report Line	29
Start Levee Mile	3.80
End Levee Mile	3.80
Location	Water Side
Category	Earthen Levee
Item	Trim / Thin Trees

View of damaged tree by beaver on waterside slope.

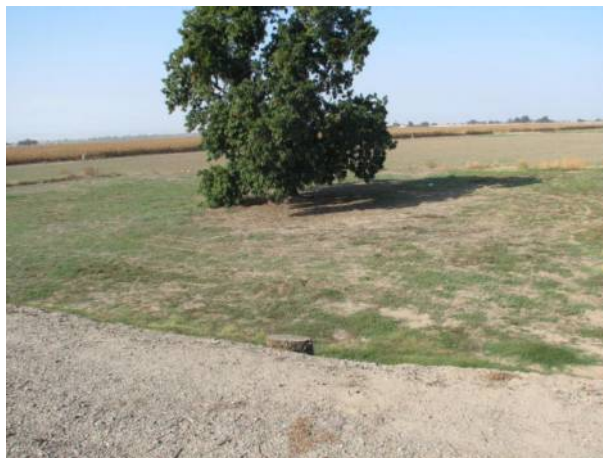
Levee Mile Report Line	32
Start Levee Mile	4.82
End Levee Mile	4.82
Location	Land Side
Category	Earthen Levee
Item	Trim / Thin Trees

10/21/2011 Photo taken the next day. Stump can be seen in the lower center of the photo.

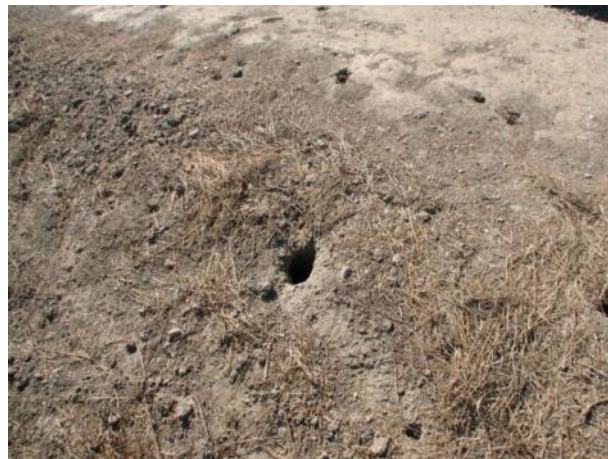
Levee Mile Report Line	33
Start Levee Mile	4.83
End Levee Mile	4.83
Location	Water Side
Category	Earthen Levee
Item	Animal Control

Animal burrows on levee slope.
